OPERATING EXPERIENCE WEEKLY SUMMARY

Office of Nuclear and Facility Safety

December 4 - December 10, 1998

Summary 98-49

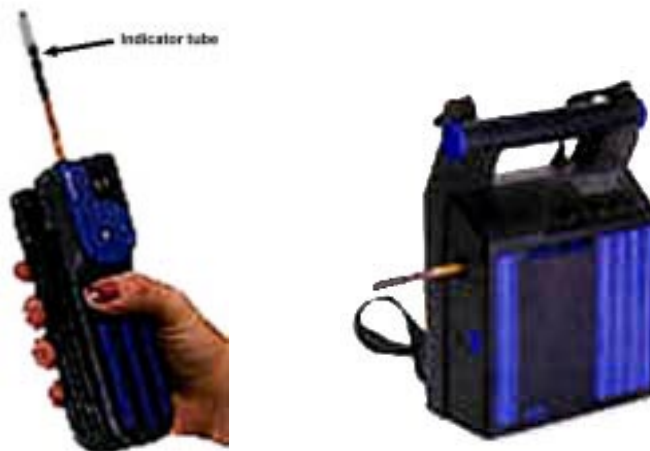
Figure 1-1. Typical Dräger Portable Gas Samplers

On December 1, 1998, personnel at the Savannah River Health Physics and Industrial Hygiene Facility received a quantity of Dräger halogenated hydrocarbon indicator tubes from a prominent supplier that were improperly packaged in a cardboard box cushioned with packing paper. The pack of tubes had an orange label stating:

WARNING - THESE TUBES CONTAIN A PYROPHORIC MATERIAL (BLACK LAYER) WHICH IGNITES IN THE PRESENCE OF OXYGEN. DO NOT USE IN THE PRESENCE OF COMBUSTIBLE GASES OR DUST. DO NOT DISPOSE OF UNUSED TUBES WITHOUT ACTIVATING THE PYROPHORIC MATERIAL PRIOR TO DISPOSAL.

Site personnel confirmed with Dräger, the indicator tube manufacturer, that the proper way to ship and store the tubes is inside a metal container to prevent ignition of surrounding combustible materials if a tube is broken. Facility personnel stored the tubes in a secure location to avoid unintentional breakage and contacted field industrial hygiene personnel to verify safe storage of existing tubes. (ORPS Report SR--WSRC-HPIH-1998-0003)

Managers of facilities that use Dräger samplers should take steps to ensure that indicator tubes containing pyrophoric material are properly stored. Procurement and industrial health organizations should verify that suppliers of these materials are aware of packaging requirements.

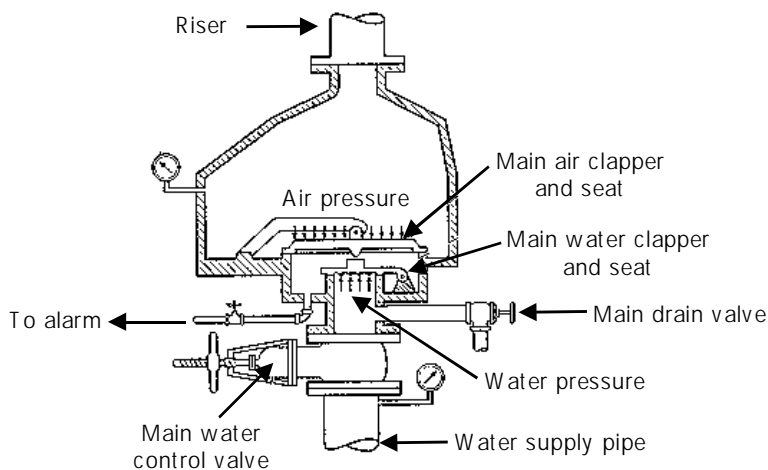
Figure 5-1. Typical Dry-Pipe Activation Valve

The sprinkler system is a supervised dry pipe system. Figure 5-1 shows a simplified dry-pipe activation valve arrangement. Fire system water pressure acts against one side of a clapper valve, and air pressure acts against the other side to keep it closed. The air side supplies a normally dry header equipped with fused sprinkler heads. When the heat of fire activates any sprinkler head, air pressure vents through the head more rapidly than the air supply system can deliver makeup. At a predetermined low pressure, the clapper valve unbalances and admits water to the riser, allowing it to flow from the open sprinkler head(s). The cylinder shed fire system also contains a set of sprinkler headers with open heads that are flooded automatically through a relay valve when the closed-head system activates. It is through this open-head system that water was admitted to the cylinder shed.

- Immediately after the occurrence, operations personnel found the normally open air charging valve in the closed position. The valve is required to be open to make up for normal system losses. Operators had closed both a water supply valve and the air supply valve to support routine testing of system low-pressure alarms. The operator who restored the system opened the air supply valve to charge the dry-pipe sprinkler headers but does not remember reclosing it. However, he does acknowledge having been involved in concurrent activities at the time.

These occurrences underscore the degree of attention that must be given to fire protection systems. The direct cause of the occurrence at Savannah River is the decrease of dry-pipe header pressure caused by a closed makeup air valve. Although investigation is incomplete, contributing and root causes and long-term corrective actions are likely to involve conduct of operations issues.

The shift superintendent did not recognize the significance of the low pressure alarm and allowed the condition to continue until the system activated. Persons in charge during off-hours cannot be expected to have all of the technical knowledge that is needed to address potential problems. However, facility managers should ensure that their allocation of resources includes qualified personnel for support of off-shift working hours, as well as weekends and holiday periods.
